# Manhole Inspection Summary

Manhole # S43CC\_057MH

Insp Date: **12/18/07 3:14 PM**

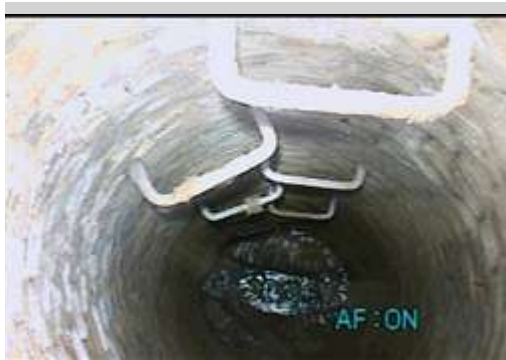
Defect 2

Count: **10** Missing: **0** ☒ **Corroded**

steps corroded

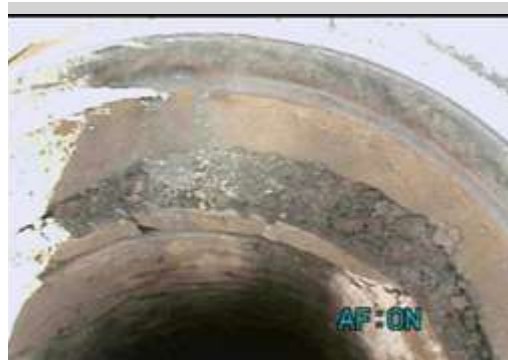
Defect 1

Offset: **1** (in.)

frame offset 1 inch

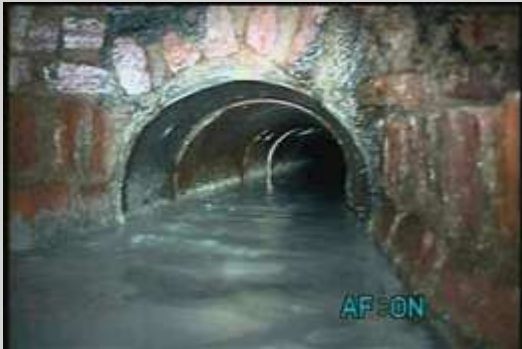
12 O'Clock Outflow

15 in. Circular Gravity Sewer  
Pipe Out @ 12 O'Clock

Pipe Material: **Clay** ☐ Pipe Lined

Invert Depth: **18.10** (ft.) Flow Characteristics: **Fast**

Deposits: ☒ None ☐ Mud ☐ Sludge ☐ Debris ☐ Grease

Infiltration: **None** Pipe Seal Cond: **Unknown**

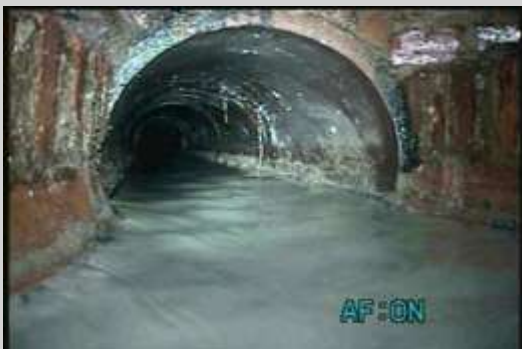
5 O'Clock Inflow

15 in. Circular Gravity Sewer  
Pipe In @ 5 O'Clock

Pipe Material: **Clay** ☐ Pipe Lined

Invert Depth: **17.50** (ft.) Flow Characteristics: **Fast**

Deposits: ☒ None ☐ Mud ☐ Sludge ☐ Debris ☐ Grease

Infiltration: **None** Pipe Seal Cond: **Unknown**

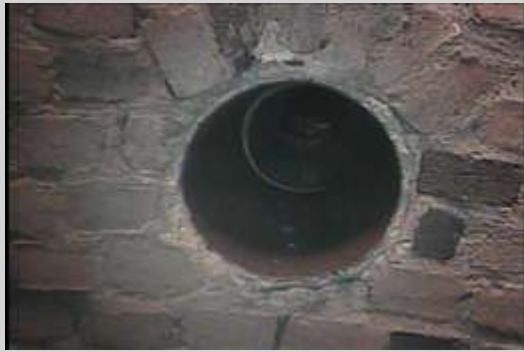
7 O'Clock Inflow

15 in. Circular Gravity Sewer

Pipe In @ 7 O'Clock

Pipe Material: **Clay** ☐ Pipe Lined

Invert Depth: **10.00** (ft.) Flow Characteristics: **Fast**

Infiltration: **None** Pipe Seal Cond: **Unknown**

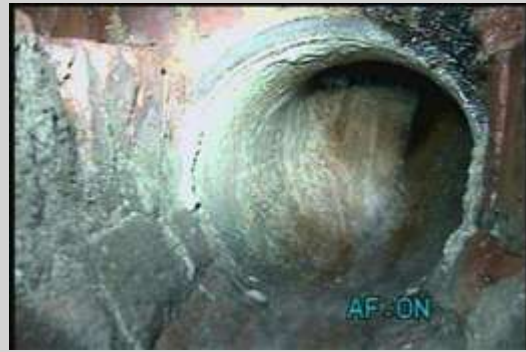
Drop In @ 7 O'Clock

Drop: **Outside**

Inv Depth: **17.40** (ft.)

Drop Condition: **Open**
